HISTORIC STRUCTURE REPORT CCC BUILDINGS

1988

CCC BUILDINGS
BANDELIER NATIONAL MONUMENT · NEW MEXICO

UNITED STATES DEPARTMENT OF THE INTERIOR / NATIONAL PARK SERVICE /
DENVER SERVICE CENTER

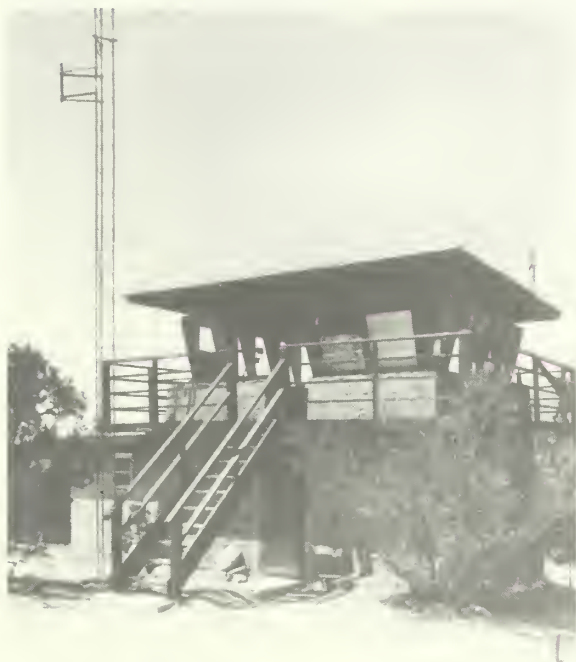
Figure 137. This photograph taken in 1982 shows the change in the angle of the windows and the 1956 addition. (Photo: Harrison for NPS)

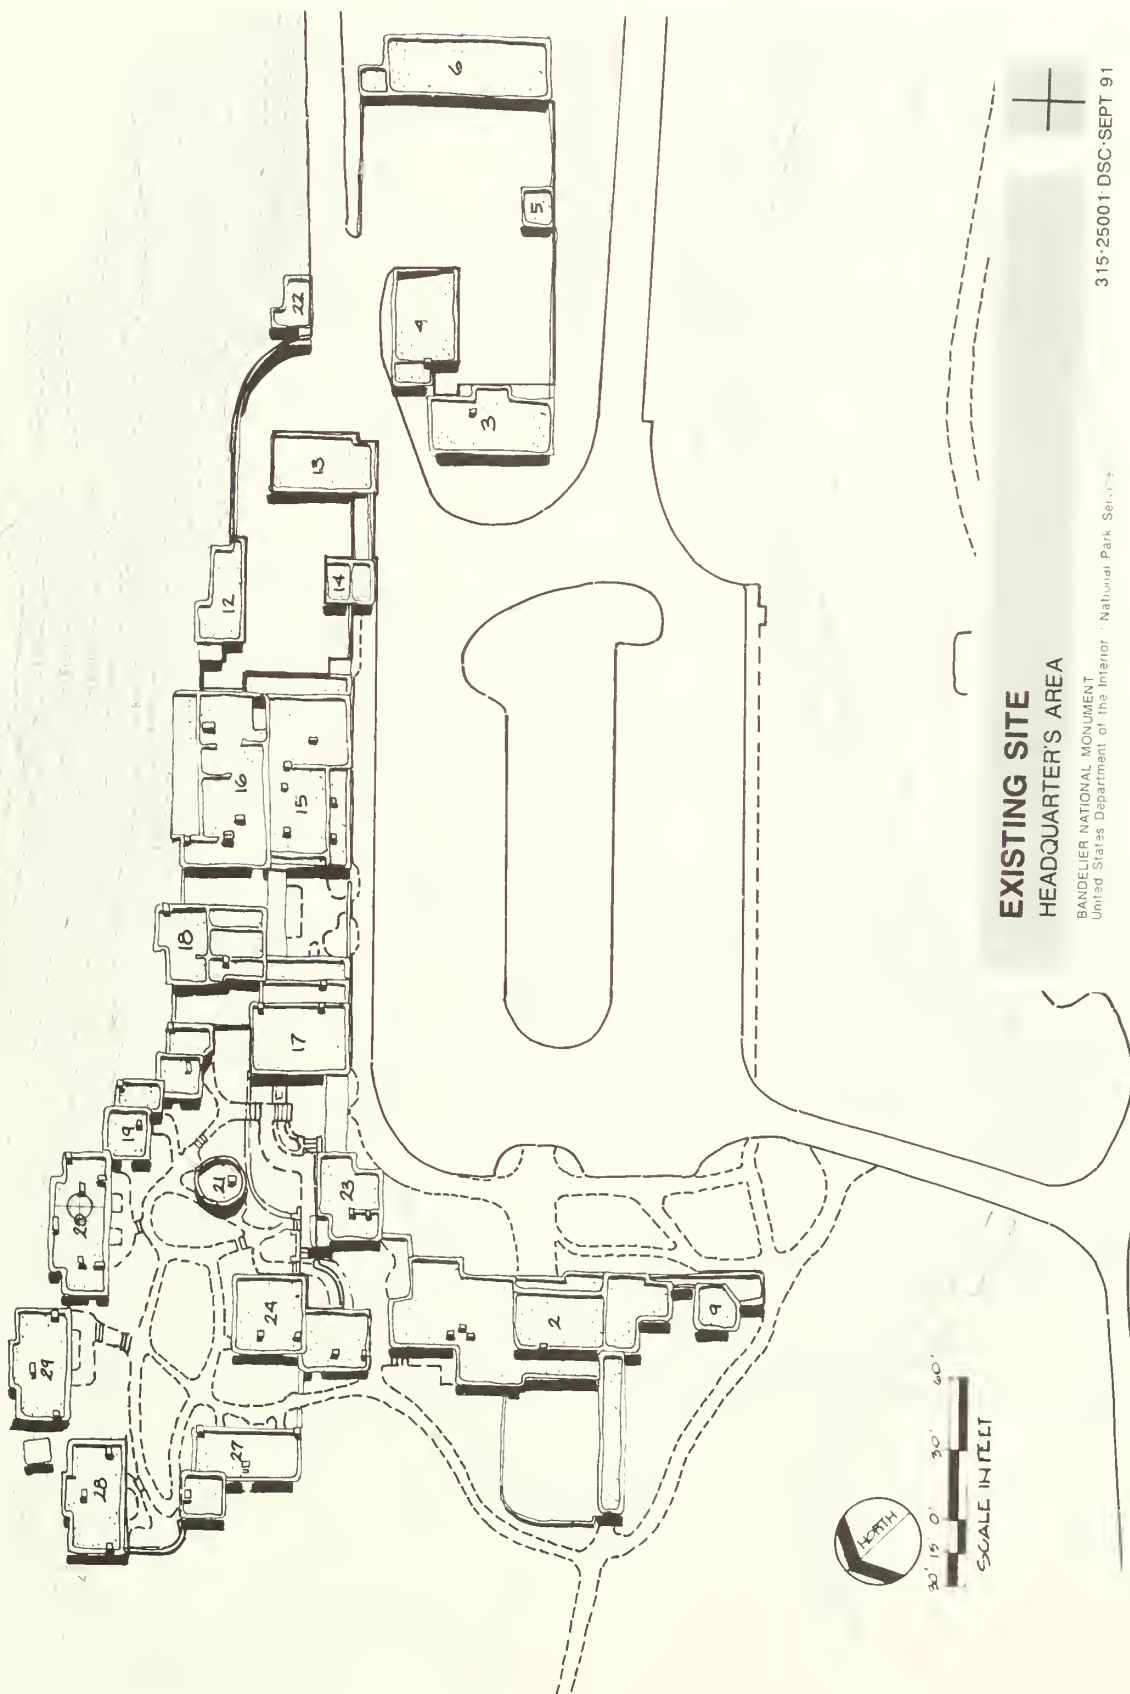
Figure 141. Existing site map

A few site modifications have occurred over the years, some of which have slightly altered the character of the area. Despite these changes, the district retains nearly all of its original feeling and character (figure 141).

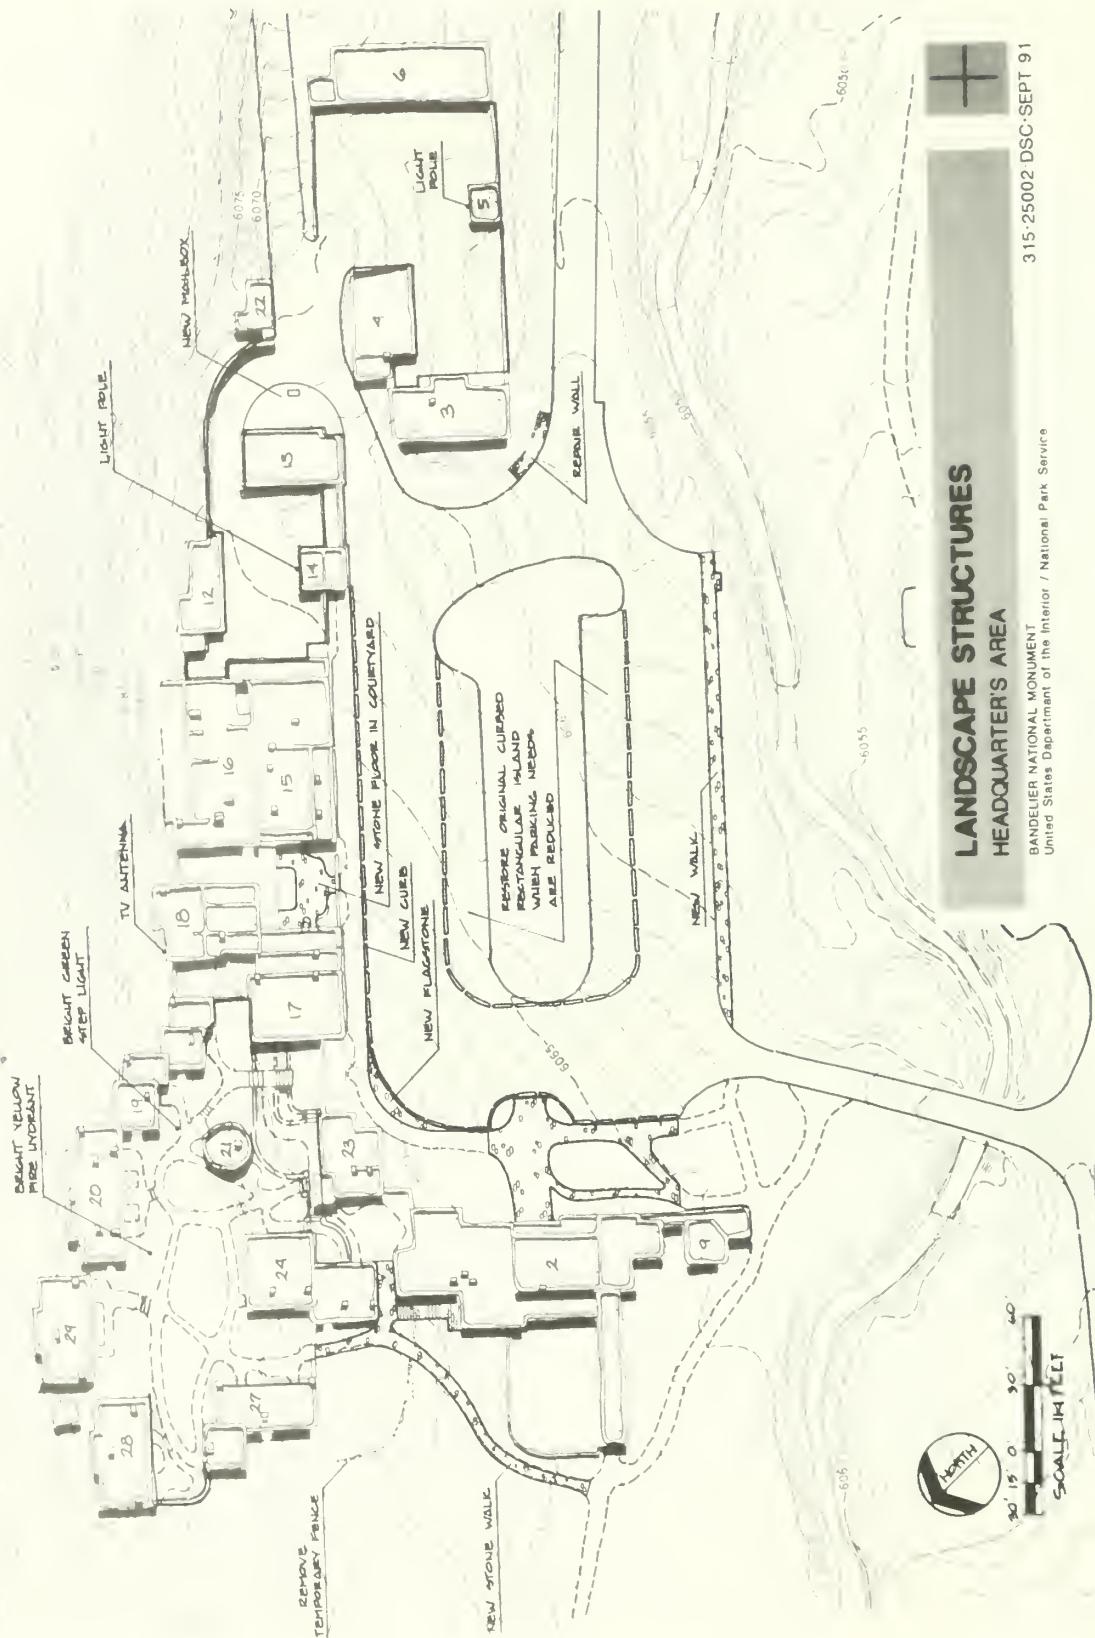
Figure 142. Landscape structures map

Because of the degradation of the flagstone over time through spalling and chipping, and because of changes in configuration brought about by more recent construction, new areas paved with flagstone now exist (figure 142). The replacement flagstone does not match the original in color or shape. The sandstone replacement is much redder, and the paver sizes are larger.

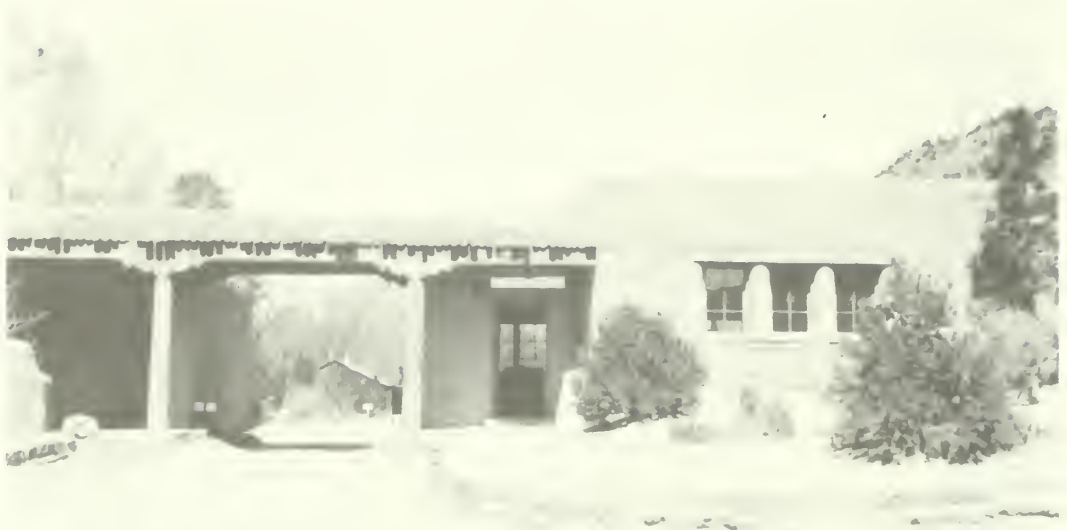
Figure 143. The front facade of the visitor center at the original drive-through, 1940. The opening has now been filled in. Many evergreen trees and native grass have been replaced with rank deciduous trees and refining lawn.

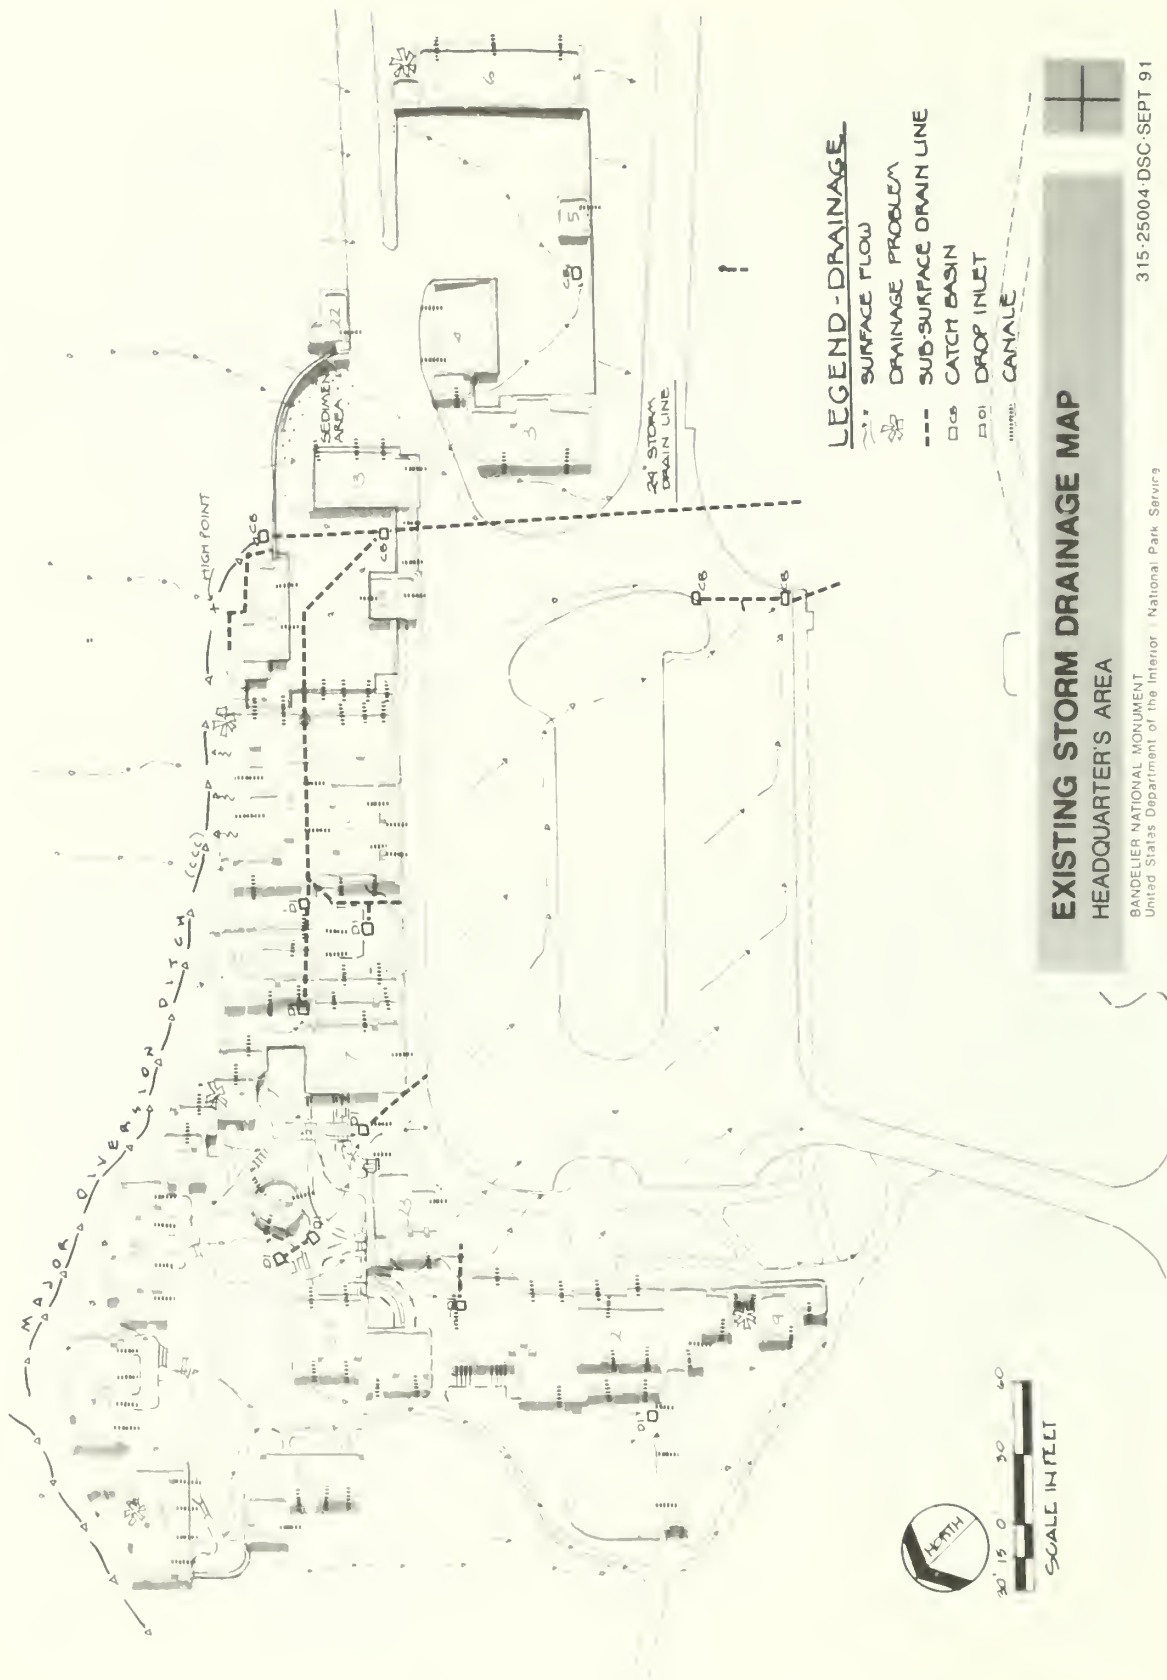
Figure 146. Existing storm drainage map

The diversion ditch uphill from the northern tier of cabins currently does not drain to the catch basin. The ditch is so porous that even a downpour immediately percolates into the ground. In addition, major downpours create a soil erosion condition that fills the ditch and the courtyards. In view of the porosity of the soil on this slope, moisture should percolate down to bedrock. However, in some isolated areas it does not percolate, and moisture seeps into building walls. The subsurface soil under the trench is a maze of utility lines (see figure 146).

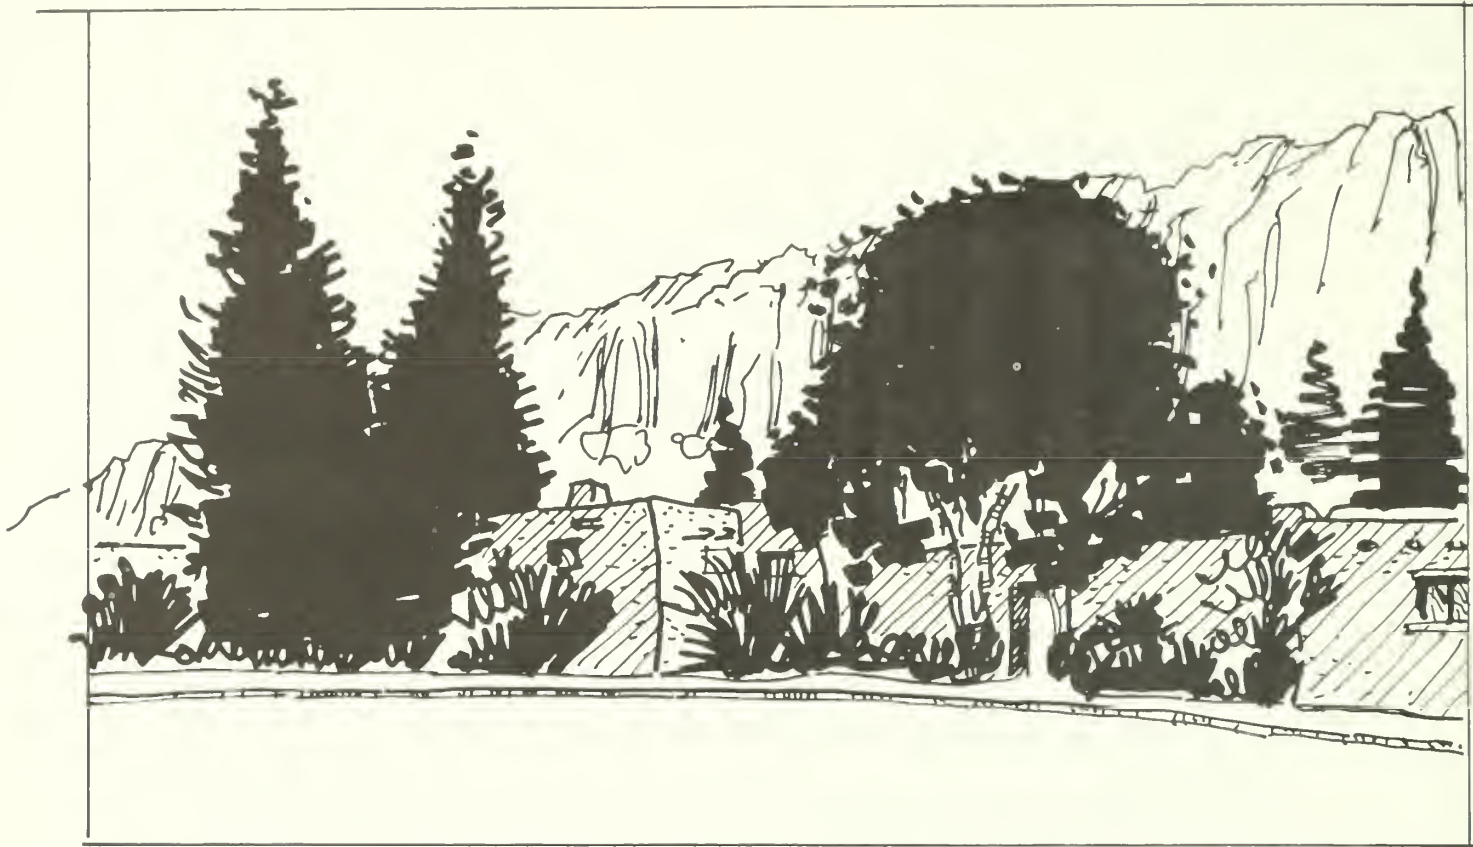
Figure 147. Existing appearance of the cabin courtyard facade.

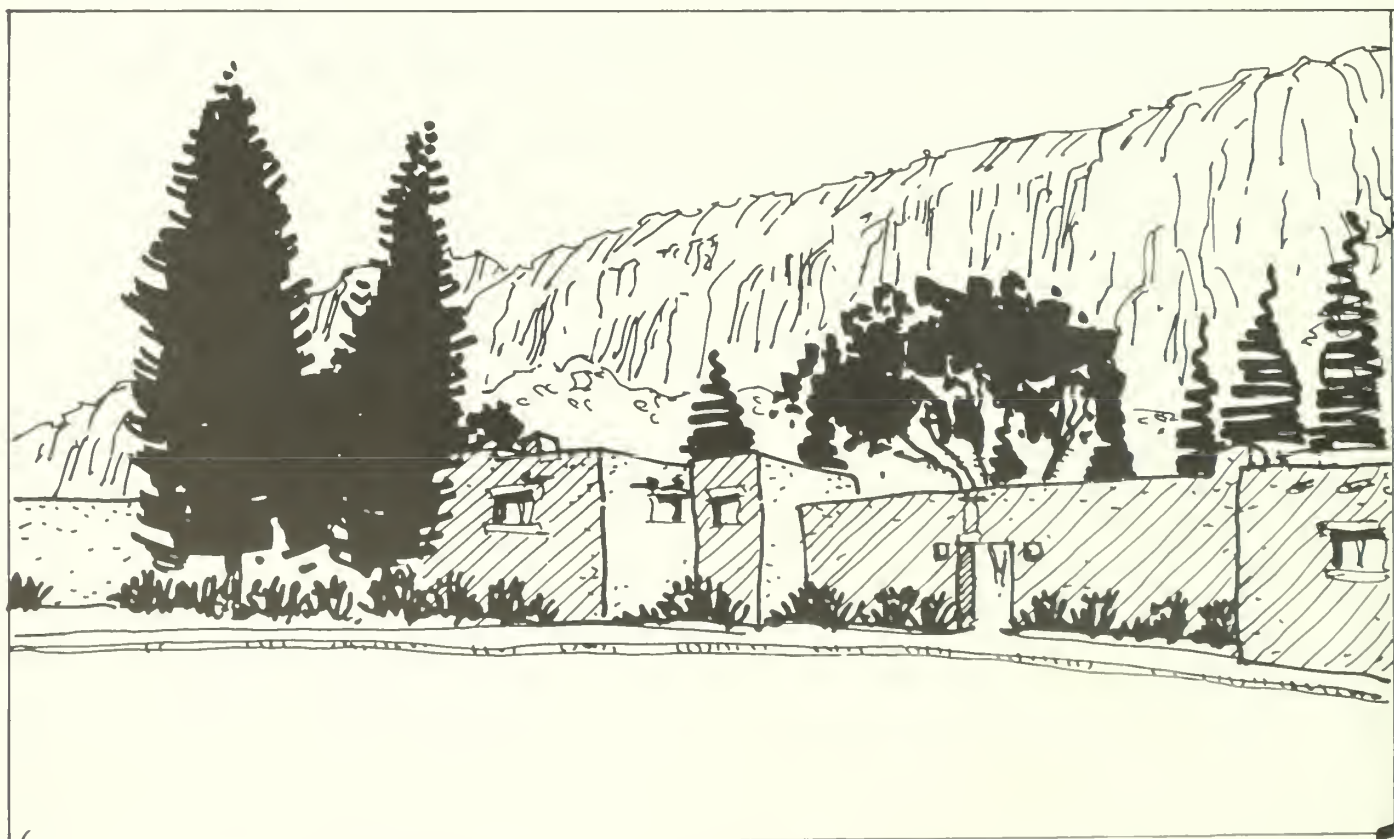
Figure 148. Recommended appearance of the cabin courtyard facade.

The original evergreen trees should be replaced as needed in kind and in the same location.

The original deciduous trees should be replaced in kind in the same location if they are well away from buildings and walls.

The total number of deciduous trees in the lower portion should be about one-half the number now present.

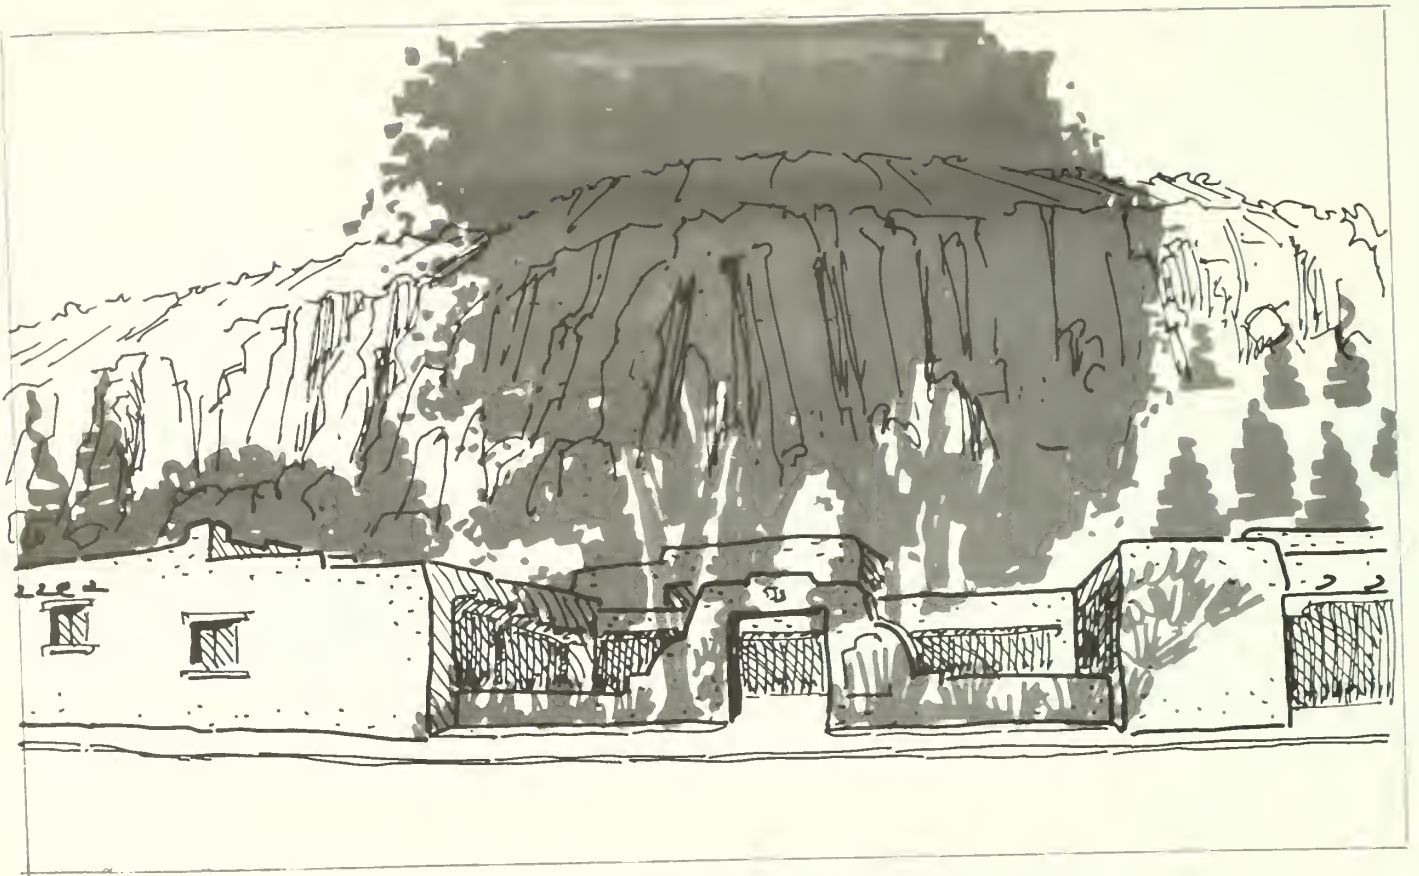
Figure 149. Existing appearance of the cafe court facade.

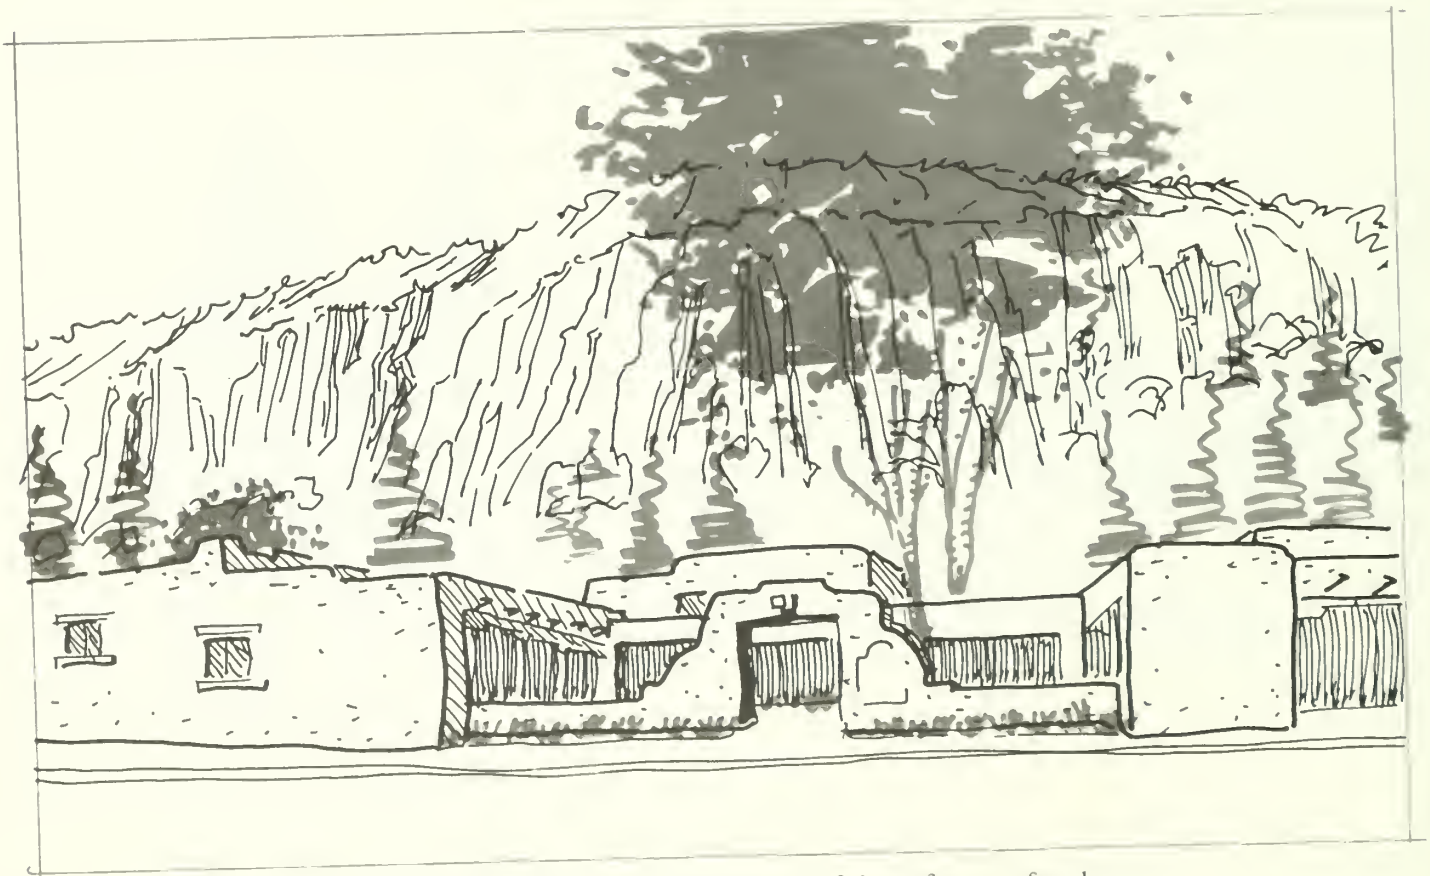
Figure 150. Recommended appearance of the cafe court facade.

Minor improvements to drainage and removal of one or two small fruit trees (which could have an effect on facility degradation) are acceptable.

The fruit trees should be pruned in a horticulturally acceptable manner.

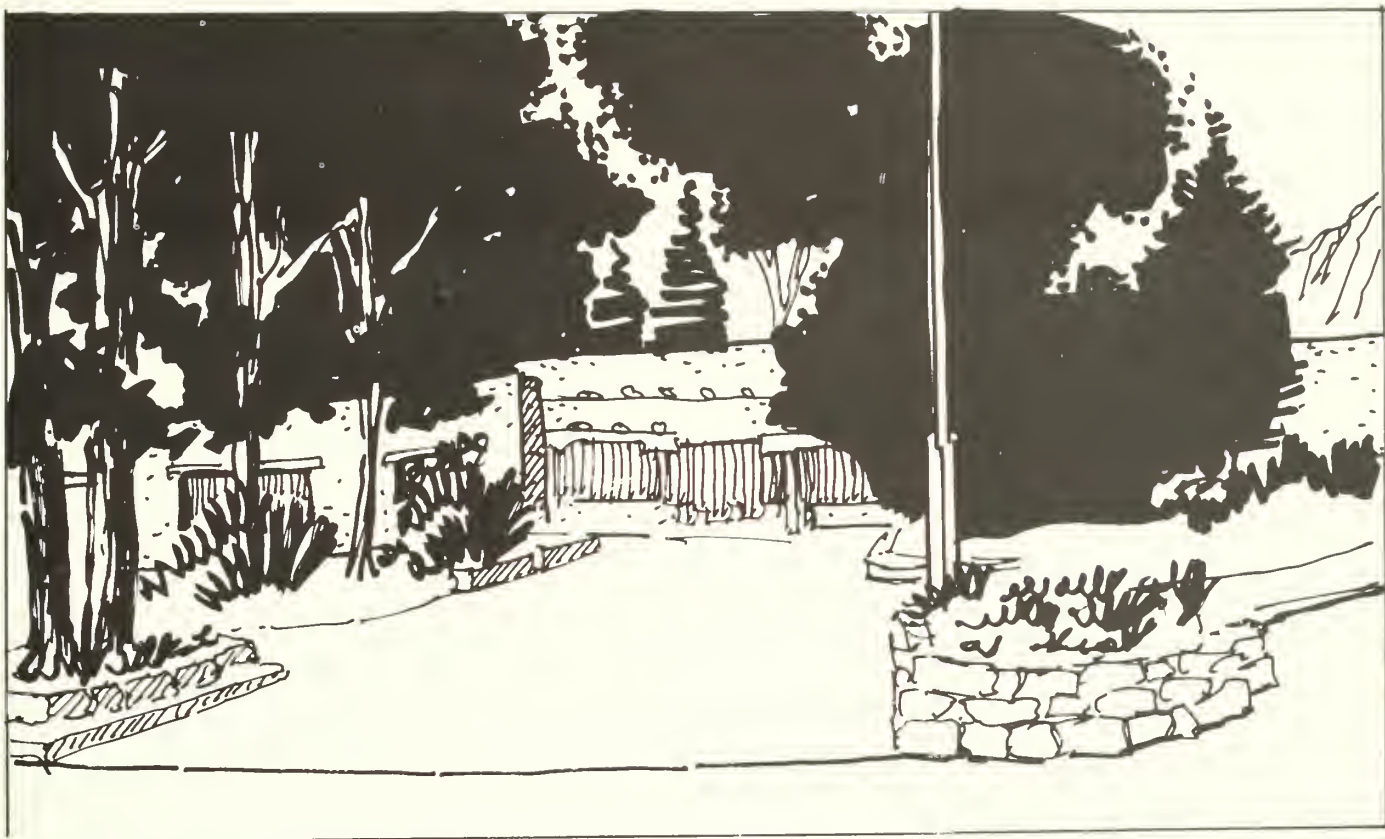
A temporary visitor control fence is in view north of the visitor center and is an intrusion to the historic site.

Deciduous plants are overgrown.

Figure 151. Existing appearance of the visitor center front facade.

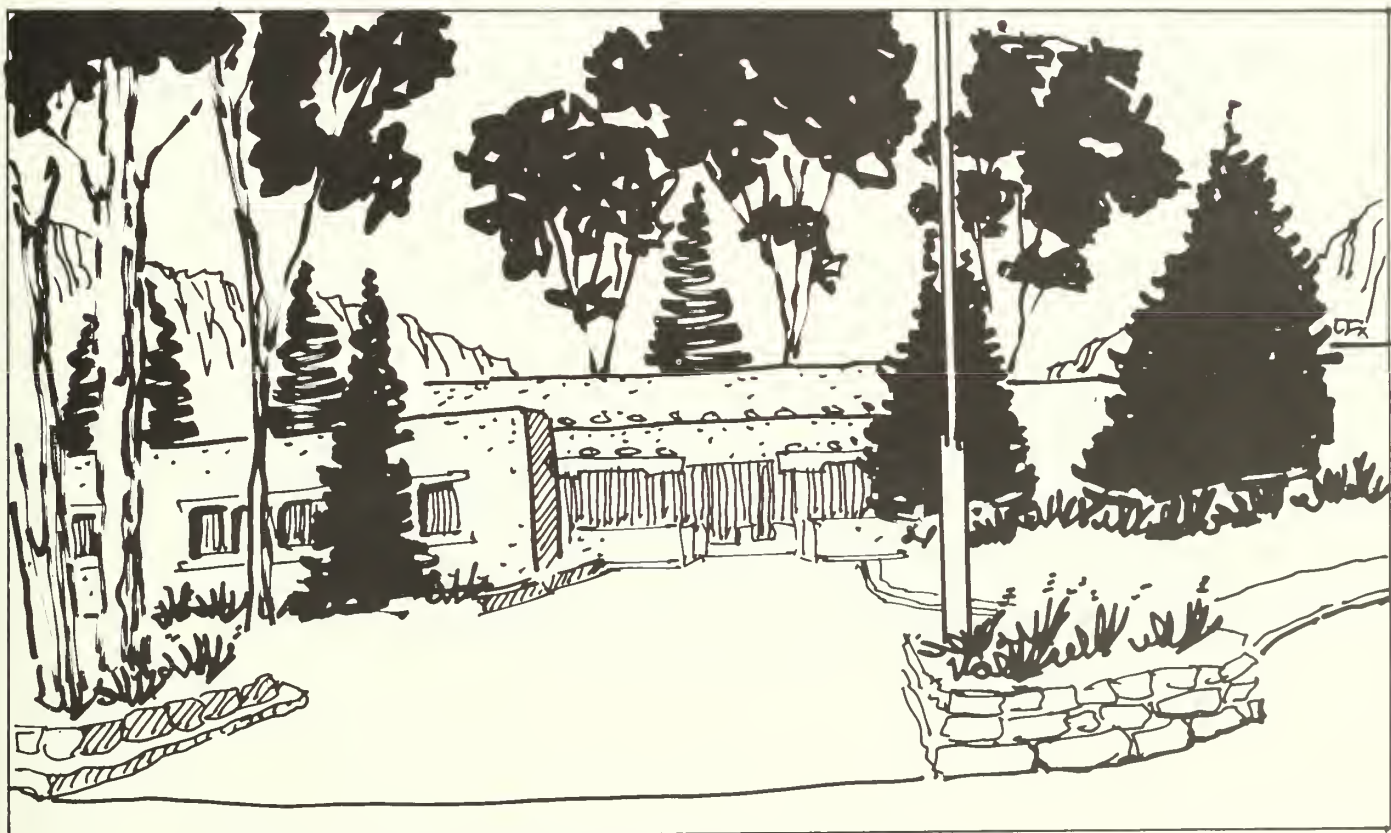
Figure 152. Recommended appearance of the visitor center front facade.

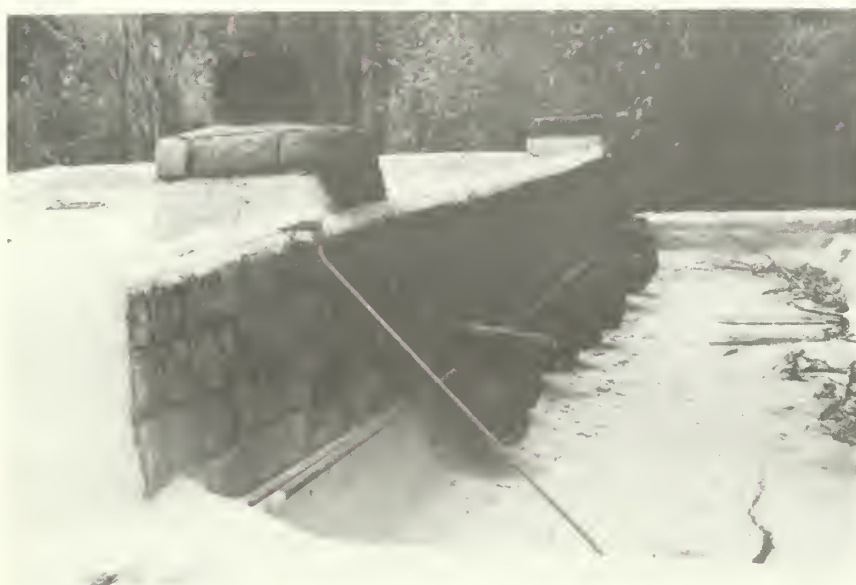
Figure 157. Roof over B-2 rear portal, 1985. Note embedded utilities, spray membrane on parapets, and fallen limbs. (Photo: Copeland for NPS)

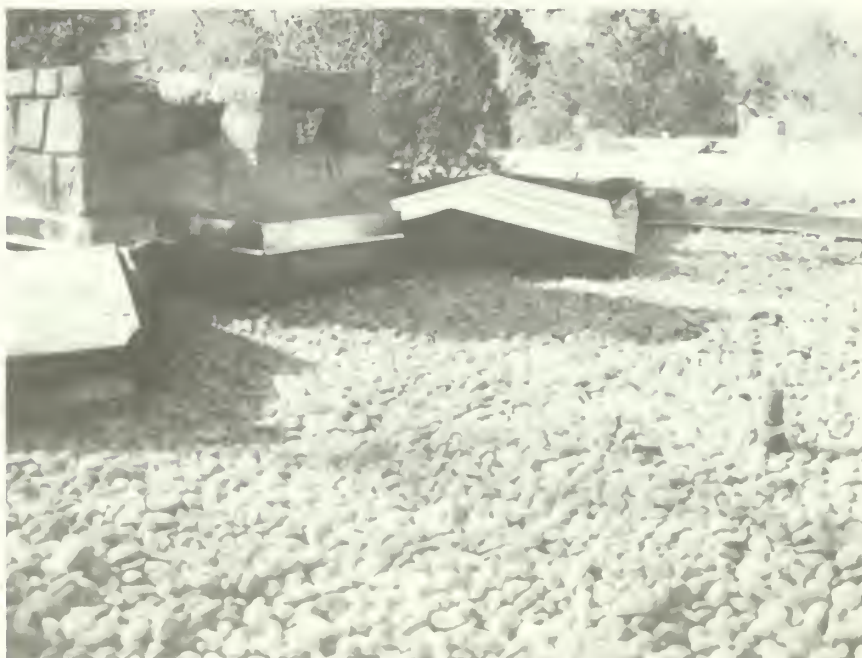
Figure 159. New ballasted roof on B-21, 1985. (Photo: Copeland for NPS)

By contrast with the above system, roof repair work executed to date under this package has used a 15-year, warranted, 45-mil, ethylene propylene (EPDM) roofing membrane, manufactured by Carlisle, with copper counterflashing. This repair has occurred on B-13, B-21, and B-26, B-7 and B-11's woodsheds, B-23's porches, and the B-29 portal, and for flashing at all replacement canales (figures 158 and 159). A gravel-ballasted system has been used to provide the required ballast and also to restore the buildings' graveled roof appearance. One dilemma in the further use of this system is the required ballast weight. A traditional composition roof weighs approximately 4 pounds per square foot; fully ballasted membranes require 10 pounds. Loading capacity is easily calculated for those buildings on which the exposed (from below) viga is also the roof rafter. On the remaining buildings where a secondary rafter system of 2x's exists (figure 160), this calculation requires no destructive investigation. Of this latter system, only B-27's actual framing system has been viewed. In this case, the secondary rafters were of varying lengths scabbed together. Because of the budgetary limitations on the buildings' original construction, it is suspected that this scabbing may well be a common occurrence. Because of a limited loading capacity in these situations, a fully ballasted membrane is a suspect alternative for future roof work without extensive rafter reinforcement or replacement; however, other methods of EPDM roof attachment exist that do not pose major concerns for structural capacity.

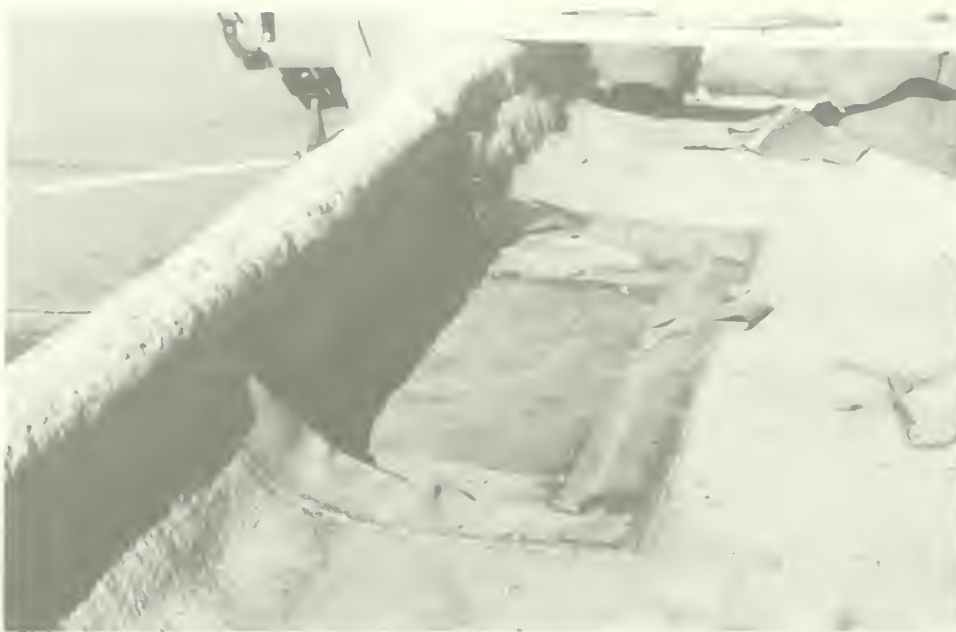
Figure 169. Installation of secondary EPDM flashing over canale copper flashing under way on B-13/14 portal. (Photo: Hose for NPS)

Following the approval of various work proposals developed as components of this historic structures report, repair work was initiated in 1986.¹ All existing canales were replaced with an EPDM membrane that extended the copper canale flashing onto the roof and parapet (figure 169). This work was done on 115 canales, 87 by contract and the balance through regional day labor forces. The EPDM membrane was applied both as additional flashing and as a potential base for future roof replacement.

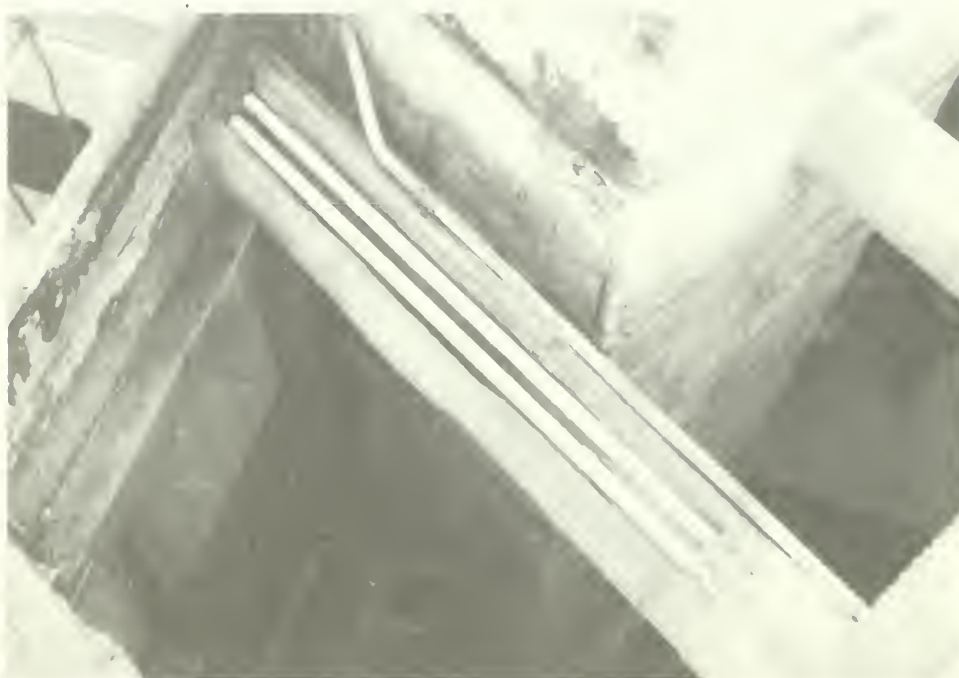
Figure 170. Structural epoxy repair, B-21, 1985. (Photo: Hose for NPS)

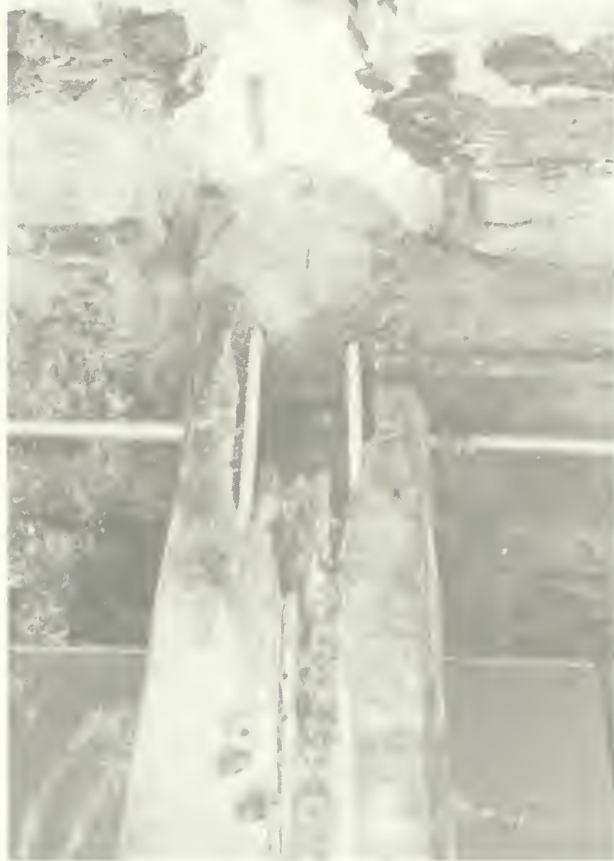
Figure 171. Structural epoxy repair and viga splice repair, B-13, 1985.
(Photo: Hose for NPS)

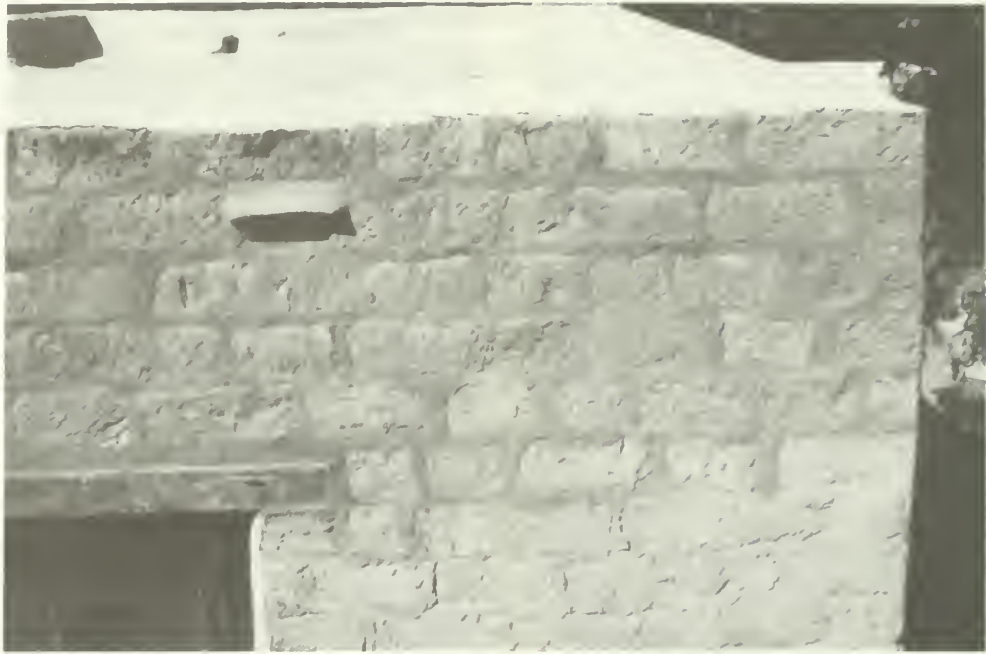
Mortar used within the stonework reportedly consisted of three different mixes: one for the foundations, one for the walls, and another for the parapets and their capping. Visual remains bear out the report and reveal that the buildings' pointing is the struck setting mortar. The majority are cement-based mixes, which, according to the original specifications, ranged from 1:3 to 1:5 (cement: sand) with 10 percent lime added. This mix is appropriate to the stone's approximate compressive strength of 850 pounds per square inch. A clay-based mortar was used to a lesser extent, primarily within the wall planes. Recent sampling and analysis for mortars and stuccos further support this range of constituent compositions. The results of this sampling from 14 buildings will be included in the historic structures preservation guide and data collection for the buildings. One noted characteristic of the mortar is its slight variation among buildings and even within a single structure. Repointing efforts over the years have been relatively compatible in color and texture but often have a smoother, more smeared tooling than the original. Their overall range and variety have perpetuated the buildings' subtle variations. Recent repointing efforts have often been too uniform and, in general, are incompatible with the original mortar in color, texture, and tooling and adversely affect the overall visual character (figure 176).

Figure 176. Detail of B-10 showing recent repointing efforts. Note the cap installed on the attic vent. (Photo: Copeland for NPS)

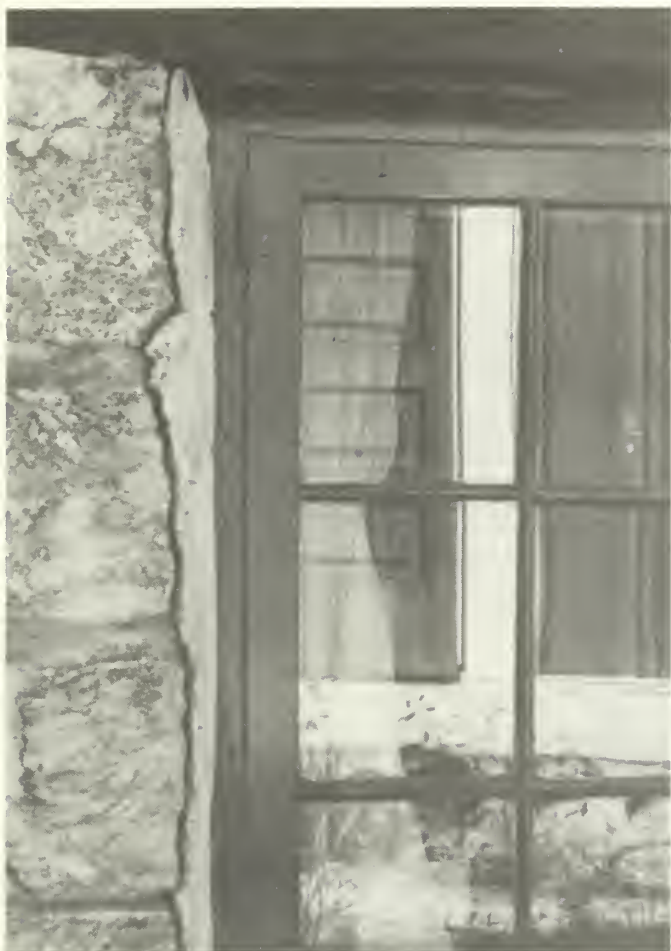
Figure 177. Detail of typical parging separation at a window jamb. (Photo: Copeland for NPS)

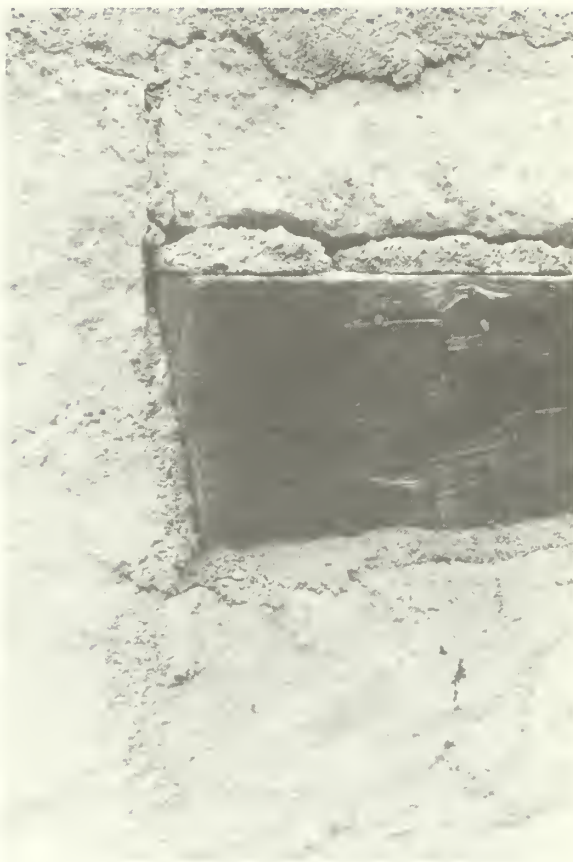
Figure 178. Detail of typical parging separation at a lintel. (Photo: Copeland for NPS)

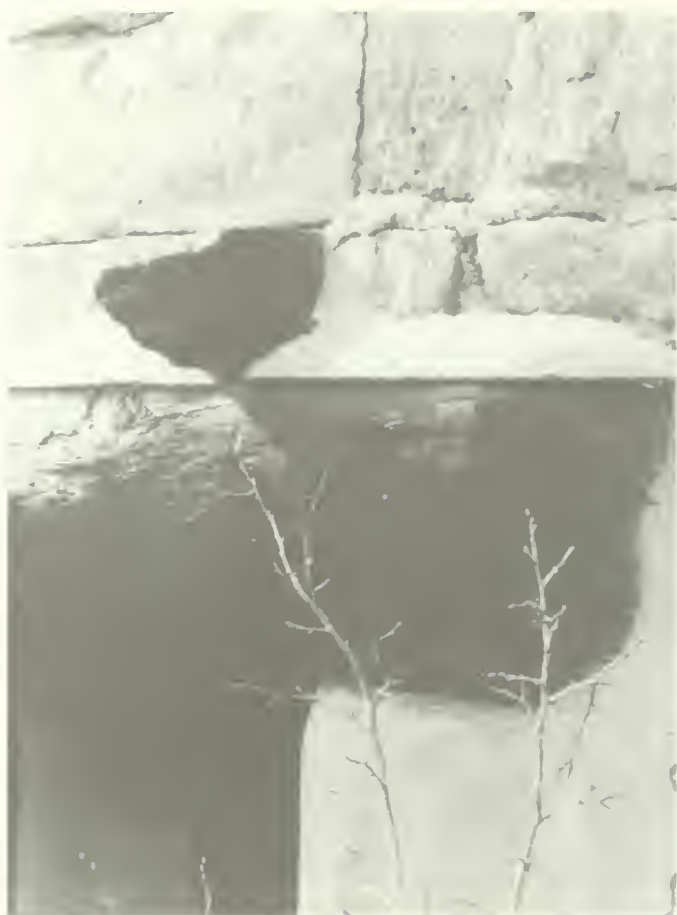
Figure 179. Detail of typical parging separation at a lintel. Note the mortar separation at the masonry overhead. (Photo: Copeland for NPS)

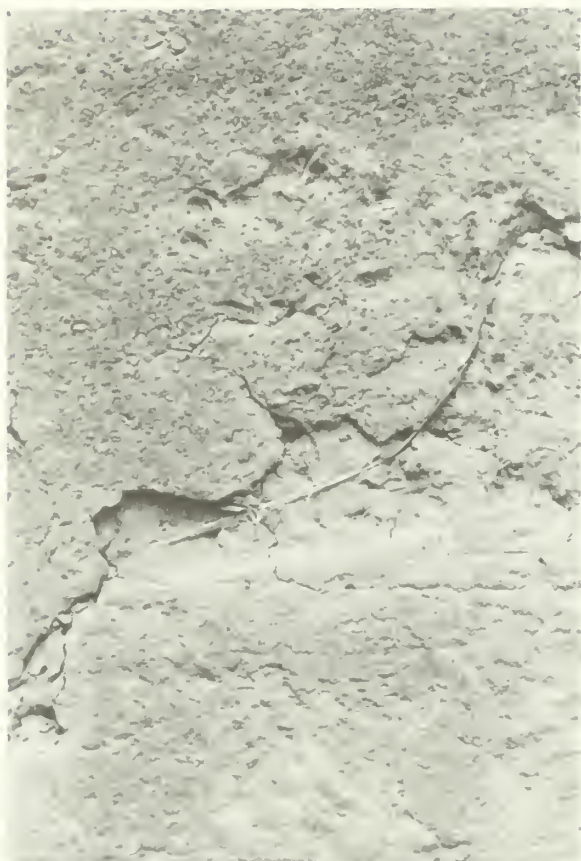
Figure 182. Detail of the original mud stucco, B-6. (Photo: Copeland for NPS)

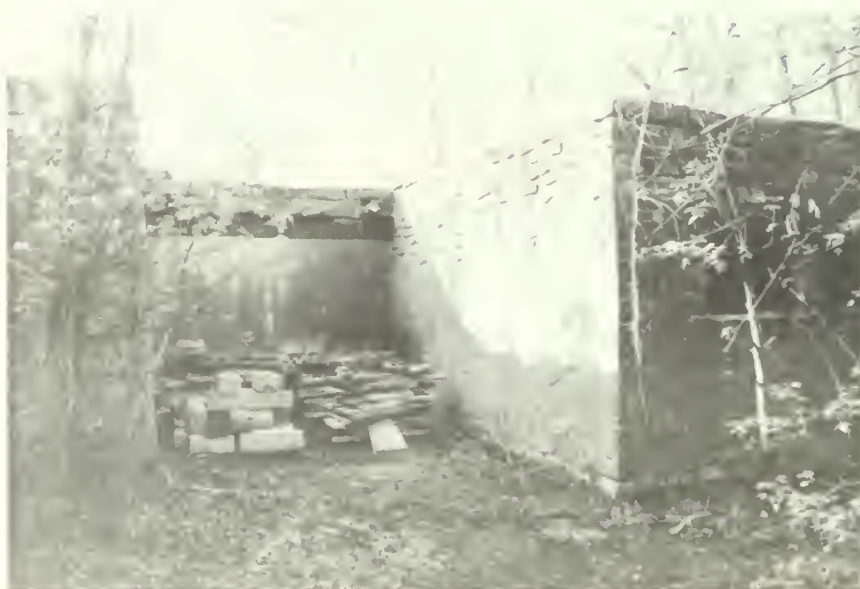
Figure 183. The rear of B-9, showing the original character of the partially stuccoed masonry. (Photo: Copeland for NPS)

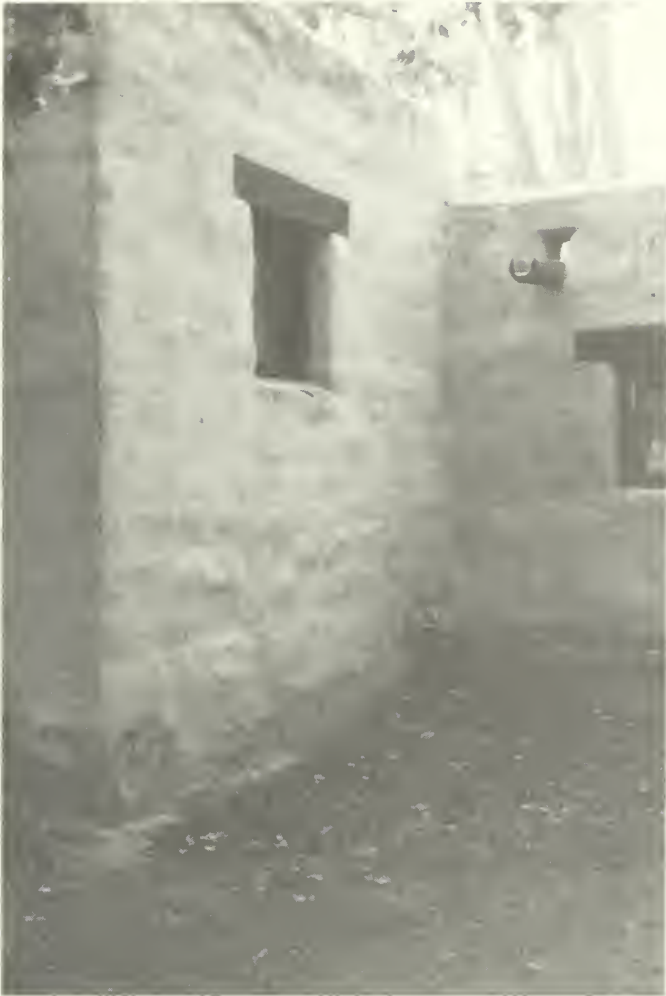
Much of the original mud stucco (or sympathetic reproductions of it) remains (figure 182). The trend toward using a stronger, cement-based, painted plaster under portals, which began in the 1940s for maintenance concerns, continues. This new material gives the walls a much harder, cleaner appearance than the original mud mix. Many of these painted wall bases under portals have a much higher painted plane than earlier schemes and today have a scalloped edge design. Although an exterior rendering may provide protection and a certain amount of sealing to the stonework, it should be remembered that the original coarse stucco was applied to provide a visual softening and artificial aging to the structures' aesthetic. Restucco efforts should retain this design intent rather than be a mere stucco wash that totally changes the essential character of the stonework (figures 183 and 184).

Figure 184. The rear of B-2, showing the change in masonry character as a result of recent restucco efforts. (Photo: Copeland for NPS)
